Survey No. S-227

Maryland Historical Trust State Historic Sites Inventory Form

1. Nam	e (indicate pr	referred name)		
historic "Su	ıffolk"			
and/or common	Polk Homestea	ıd		
2. Loca	ation			
street & number	N.E. Side of Co	ourthouse Hill Road		not for publication
city, town Co	kebury	_X_ vicinity of	congressional district	First
state Mar	yland	county	Somerset	
	sification			
Category	Ownership	Status	Present Use	
district- _X_ building(s)	public _X_ private	occupied _X_ unoccupied	agriculture commercial	museum park
structure	both	work in progress	educational	_X private residence
site object	Public Acquisition in process	Accessible _X_ yes: restricted	entertainment government	religious scientific
Object	being considered	yes: unrestricted	jovernment	transportation
	X not applicable	no	military	other:
name street & number	Polk		telephone no	o.:
city, town	comoke City	state	and zip code Mary	vland
		al Description		
courthouse, regis	stry of deeds, etc. Sor	merset Clerk of Cour	t	liber

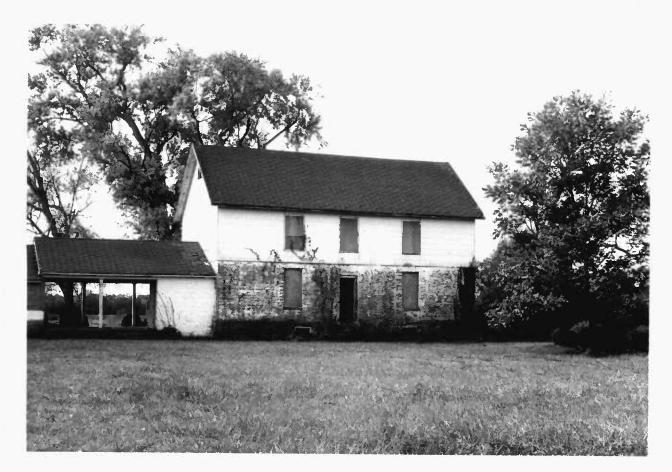
"Suffolk"
Near Pocomoke Ciry
Northeast Elevation
11/83 Paul Touart
Neg./Maryland Historic Trust

To the rear is a similarly detailed facade with disfigured brickwork around each opening. However, between the entrance and right bay it appears another entrance has been bricked up. Two cellar openings pierce the foundation brick.

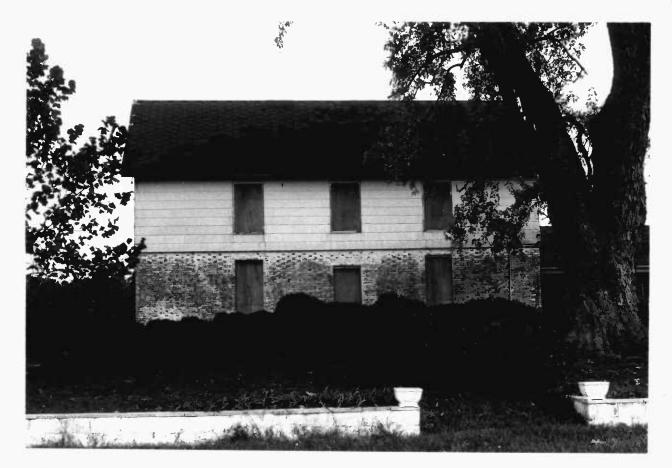
"Suffolk"
Near Pocomoke City
Southwest Elevation
11/83 Paul Touart
Neg./Maryland Historic Trust

The southwest (main) facade of the early brick house is pierced by three openings with a central entrance flanked by window openings. The doorway appears to have been made smaller with newer fill brick. A beveled water table runs below the openings. The second floor is marked by three evenly spaced window openings.

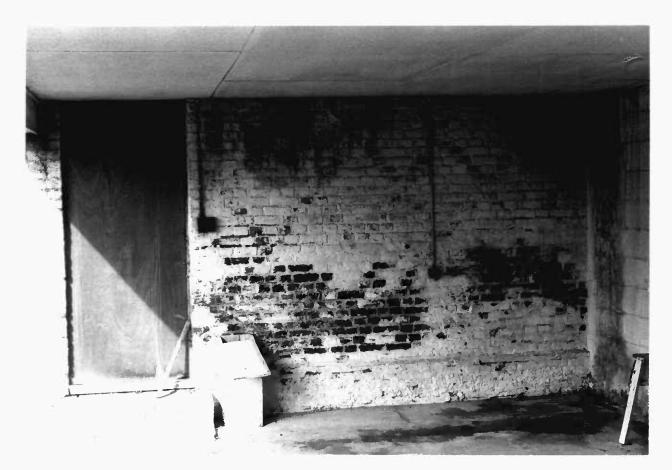
"Suffolk"
Near Pocomoke City
Southeast Gable End
11/83 Paul Touart
Neg./Maryland Historic Trust

Standing in a grove of trees and among mature boxwood are the remains of a c. 1700-1750 Flemish bond brick house (41'8" X 22'6") with glazed header checkerboard pattern. Featured on the southeast gable end is a glazed brick diaper pattern. In 1922, this early house burned and the interior was gutted. The gable end walls were evidently leveled off and the structure was raised to a two-story height by frame. At some point the brickwork was painted white, and the weatherboards were covered with asbestos shingles. The steeply pitched asphalt tile roof has extended eaves and sloped soffits.

The southeast gable end is partially covered by a c. 1922 breezeway addition and garage. In addition, a basement entrance has been cut through the foundation wall. Under the fading white paint it is evident the glazed headers are laid in a diaper pattern. An exterior entrance is located in the left bay.
